# Typical solar farm construction on distribution in the Carolinas

# Fault event at solar farm causes customer disruption

- This experience raised awareness of MV construction at solar farms
  - Exposure:
    - >200 solar farms (≥ 1 MW) in Duke Energy Progress
    - Average size = 4.4 MW
    - Total = 926 MW
- Duke then initiated "investigative inspections" of 8 sites
  - results mixed, but not reassuring

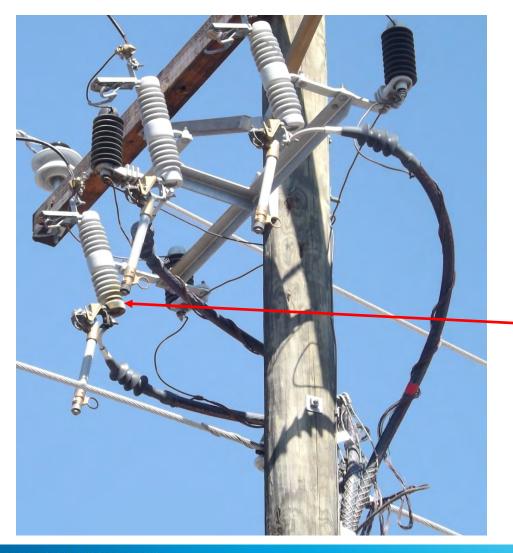
20 MW solar farm site inspection, after second occurrence

dip pole "B" (7th pole)

fault evidence

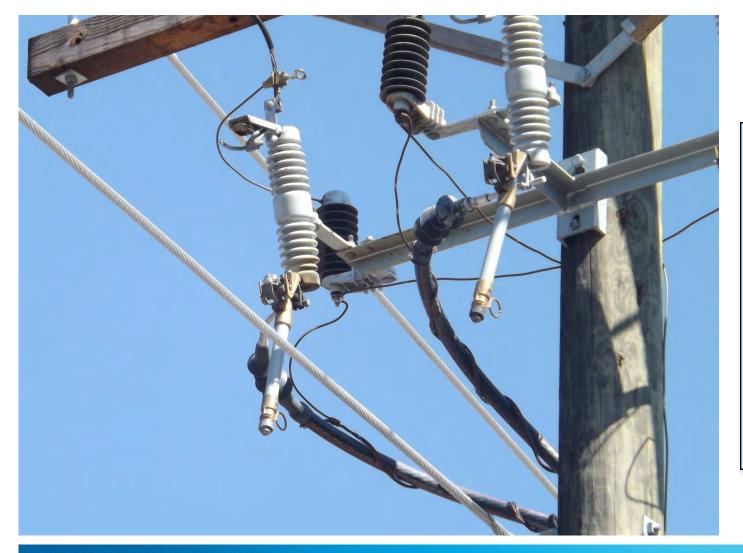
20 MW solar farm, at dip pole "B":

- C (left) phase fault, developed into phaseto-phase fault
- occurred twice in 15 days

Primary issues identified:

- clearances at stress cones
- terminations

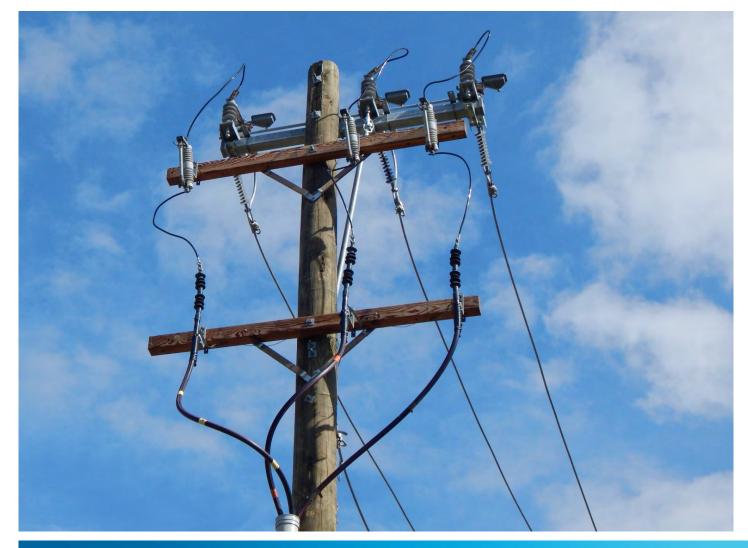
No lightning arresters on any of the 3 dip poles

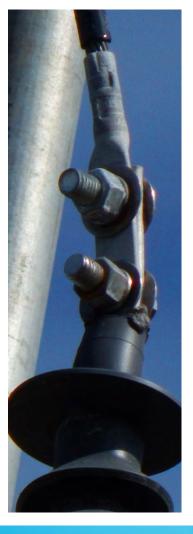
At one site, none of the connections were greased

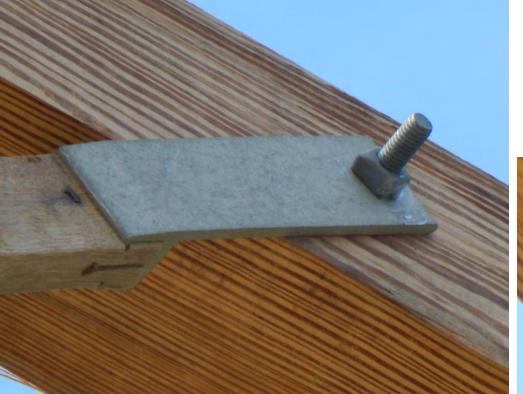
Lockwashers?

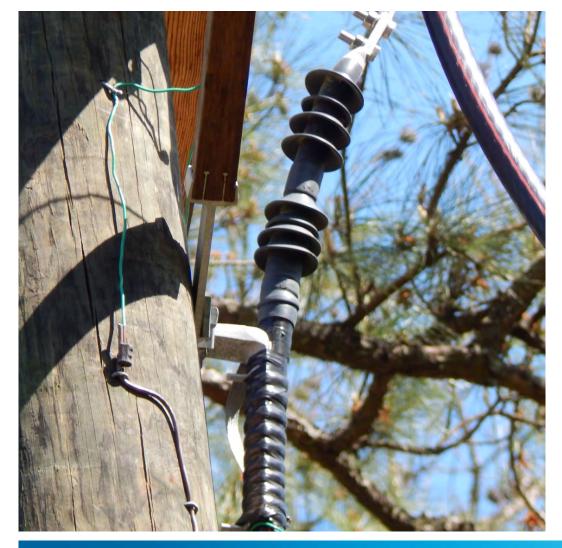
Terminator installed incorrectly.

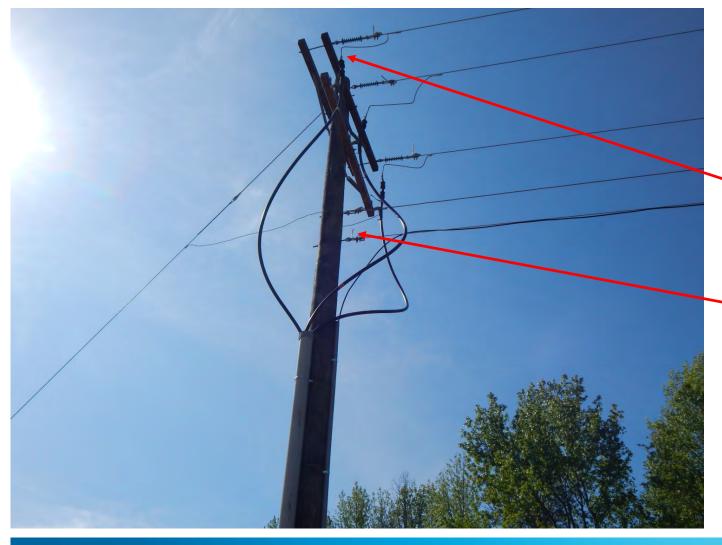
Reverse dip through wetlands. No arrester protection for terminations.

Messenger wire for fiber is not bonded at all 3 poles (possible induced voltage).

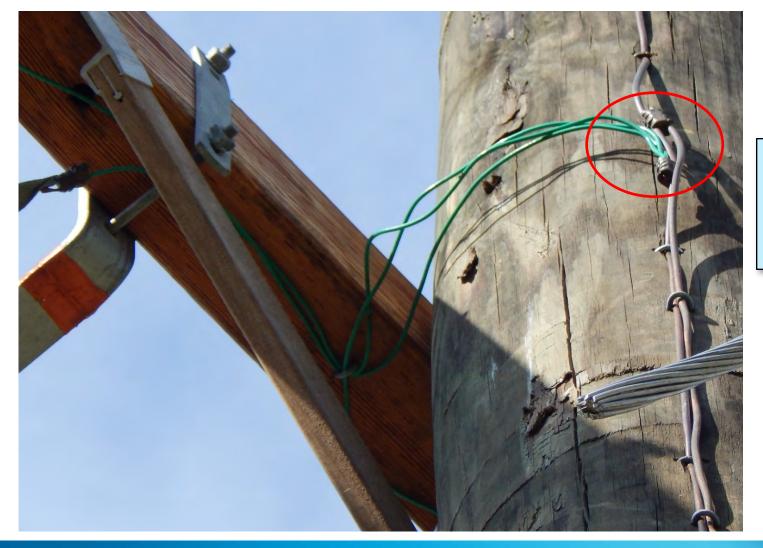
Underground primary cable neutral bonded to very small wire. Weak link.

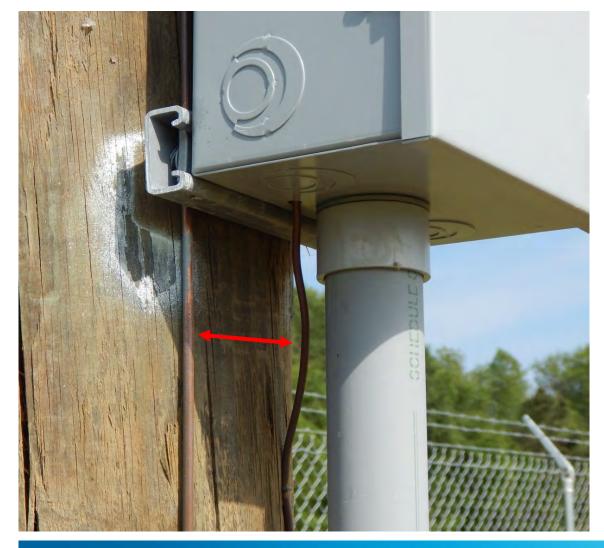
Switch is grounded with separate ground. Pole ground and switch ground should be commonly bonded.

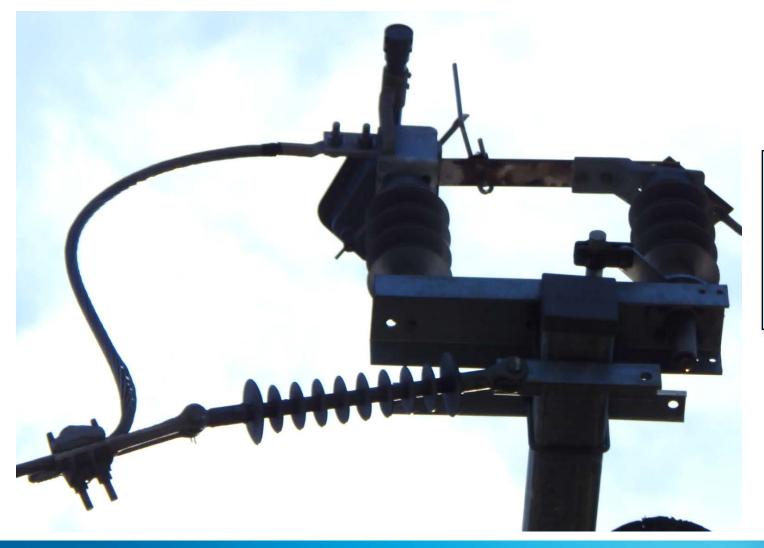
Metal base of switch extends half way over deadend insulator.

Extension link needed.

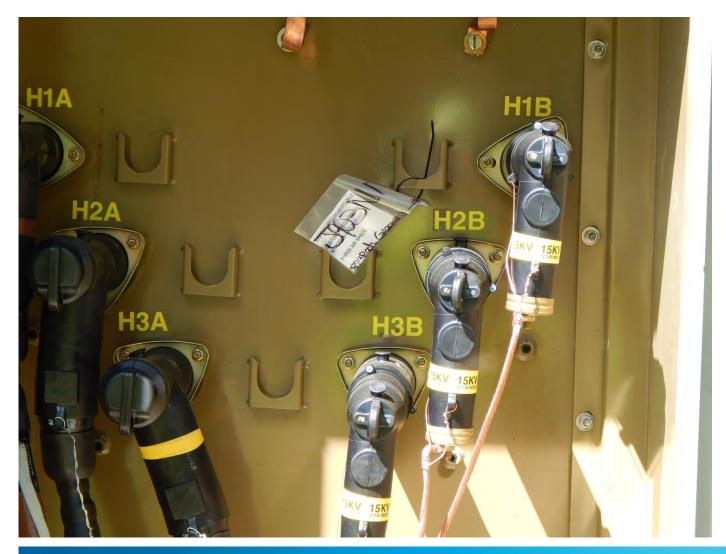
12.7kV MCOV rating on arrester

(system here is 22.86 kV/13.2 kV)

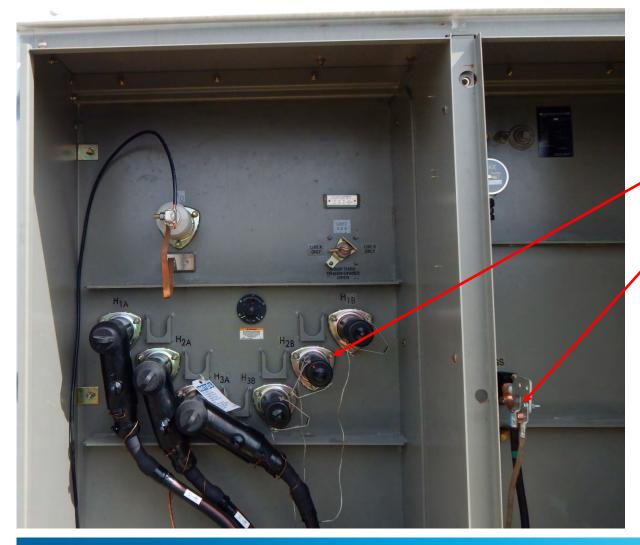
Deadend caps installed with no arresters.

Flat to flat connections ungreased.

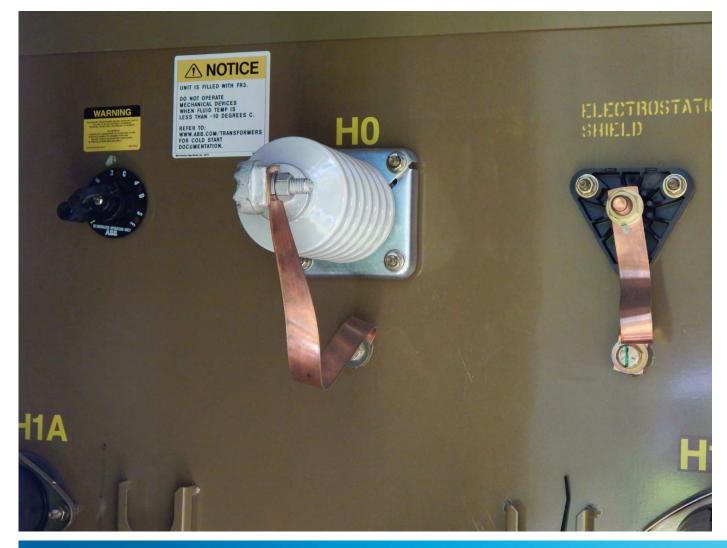
H0 bushing ground strap installed, but no connection to ground bus in transformer.

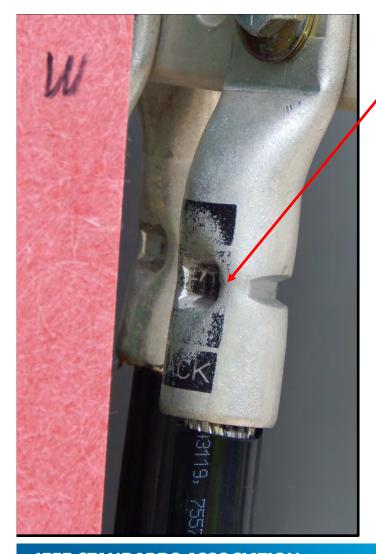
Only 1 crimp on every connector.

Tooling: pp. 876-892 Die Selector Chart: pp. 893-895

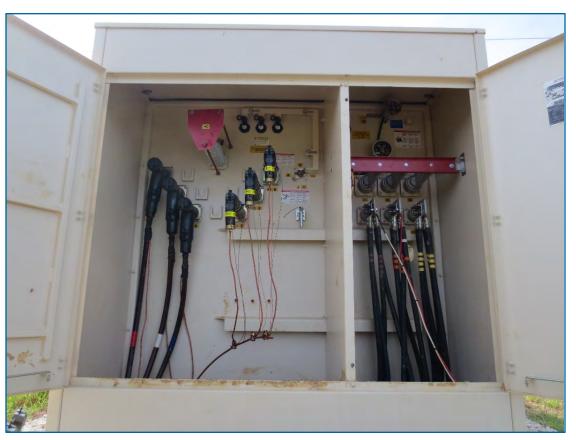
- One site has 830 kVA transformers, each with two secondary windings rated for 415 kVA each
- At one of the transformers, an 830 kVA inverter is wired to one of the two 415 kVA secondary windings, overloading the transformer

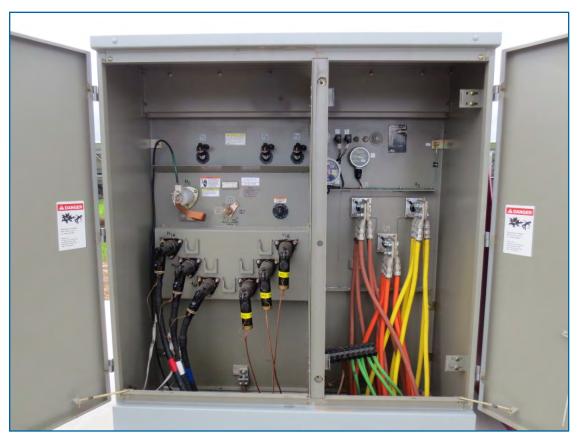
At one site, improperly rated 600 V insulated wire is used on 690 V inverter AC output circuits
