Corrections to

**Information technology—
Telecommunications and information exchange between systems—
Local and metropolitan area networks—Specific requirements—**

Part 3: Carrier sense multiple access with collision detection (CSMA/CD) access method and physical layer specifications

Correction Sheet

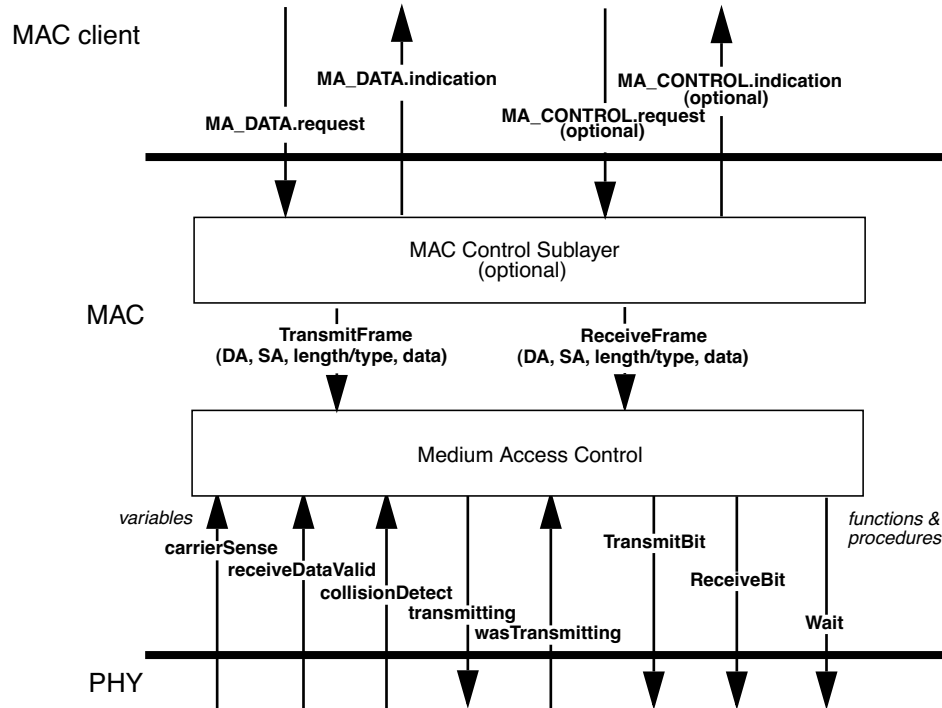
**Figure 2-2—Service specification primitive relationships
(optional MAC control sublayer implemented)**

NOTE—The deletion of the wasTransmitting arrow, restored by the above, has been proposed by an IEEE P802.3 Revision Request, (URL - http://www.ieee802.org/3/maint/requests/maint_1021.pdf) which is currently being balloted as part of IEEE P802.3ag Maintenance Ballot #6. This was published in IEEE Std 802.3, 2000 Edition in error.

Page 34: Figure 2-2.

Replace Figure 2-2 with the following figure.
